Manhole Inspection Summary

Manhole # S31SS_044MH

Insp Date: **5/14/07 10:36 AM**

Location Address: **203 28TH ST**

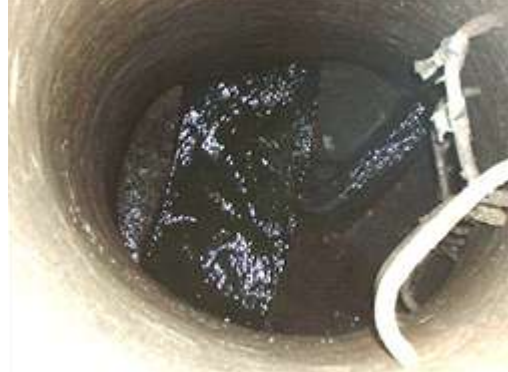
Top View

☒ **Debris** (not Condition related)

☒ **Evidence Of Surcharge**

Evidence of surcharge - Bench debris.

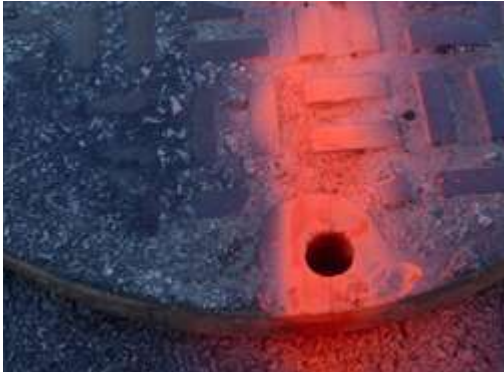
Defect

Condition: **Cracked**

Cracked lid.

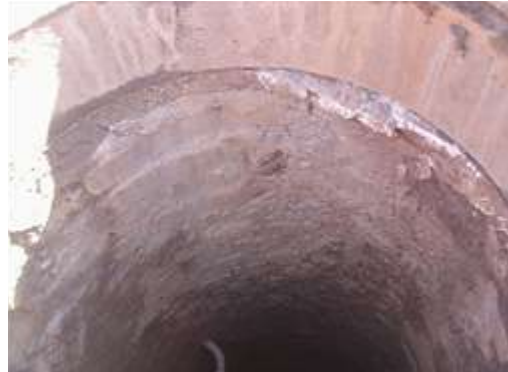
Defect

Frame leaks. Adjustment deterioration and infiltration. Corbel and Barrel infiltration - other side.

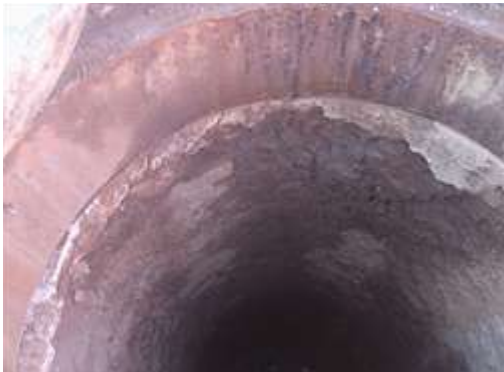
Defect

☒ **Leaks**

Condition: ☐ Sound ☐ Cracked ☐ Root Intrusion ☐ Loose Brick ☒ **Deteriorated**

Infiltration: ☐ None ☒ **Joint** ☐ Cracks ☒ **Mortar** ☐ Roots ☐ Wall

Frame leaks. Adjustment deterioration and infiltration. Corbel and Barrel infiltration.
